Geotechnical Engineering Report

Proposed Medical Center

Bolivar, Missouri

Project No. B5155041

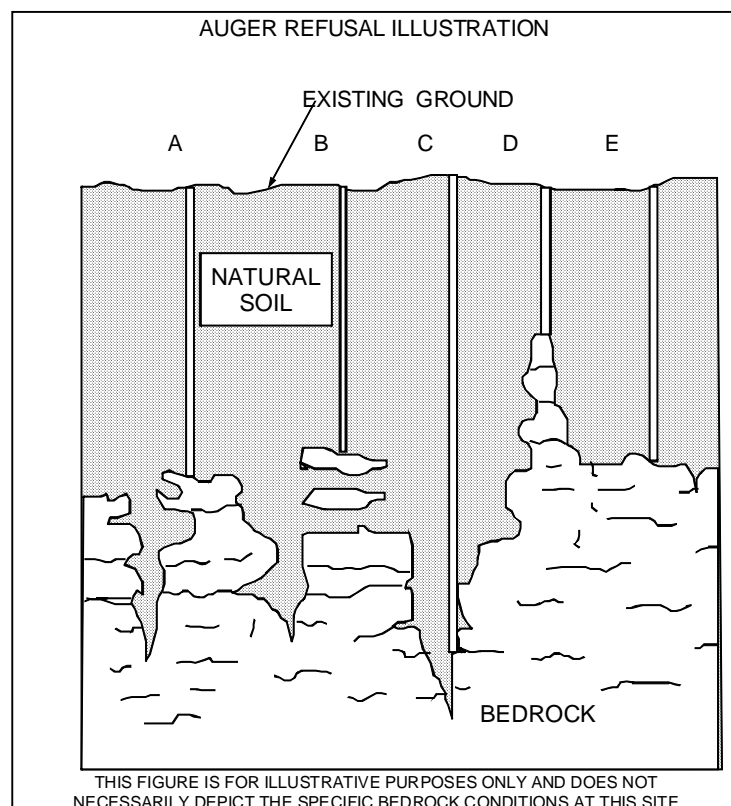
Auger refusal on apparent bedrock was encountered in borings B-1 through B-4 at depths between 16 and 29 feet below present grades. Auger refusal is defined as the depth below the ground surface at which a boring can no longer be advanced with the soil drilling technique being used. Auger refusal is subjective and is based upon the type of drilling equipment used, the types of augers being used, and the effort exerted by the driller. Auger refusal can result on the upper surface of discontinuous bedrock (A), slabs of unweathered rock suspended in the residual soil matrix or "floaters" (B), in widened joints that may extend well below the surrounding bedrock surface (C), on rock "pinnacles" (D) rising above the surrounding bedrock surface, or on the upper surface of continuous bedrock (E). These possible auger refusal conditions are illustrated in the adjacent figure.

When the proposed grading plan is available and prior to foundation construction, borings or auger probes could be performed to obtain more bedrock information. Linear interpolation of apparent bedrock elevations based upon the boring data is often used but can misrepresent actual rock removal quantities where such anomalies exist.

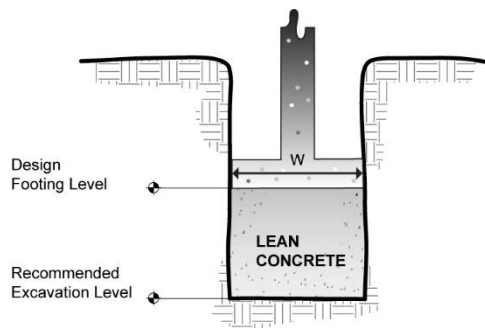
Lean Concrete Backfill

If unsuitable bearing soils (e.g., undocumented fill or soft native soils) are encountered in footing excavations, the excavation should be extended deeper to suitable soils. The footing could then bear directly on these soils at the lower level or on lean concrete backfill placed in the excavations. As an alternative, the footings could also bear on properly compacted structural backfill extending down to the suitable soils. Overexcavation for compacted structural fill placement below footings should extend laterally beyond all edges of the footings at least 8 inches per foot of overexcavation depth below footing base elevation. The overexcavation should then be backfilled per the recommendations provided in section **4.2 Earthwork** up to the footing base elevation. The overexcavation and backfill procedure is illustrated in the following figure.

NOTE: Excavations in sketches shown vertical for convenience. Excavations should be sloped as necessary for safety.

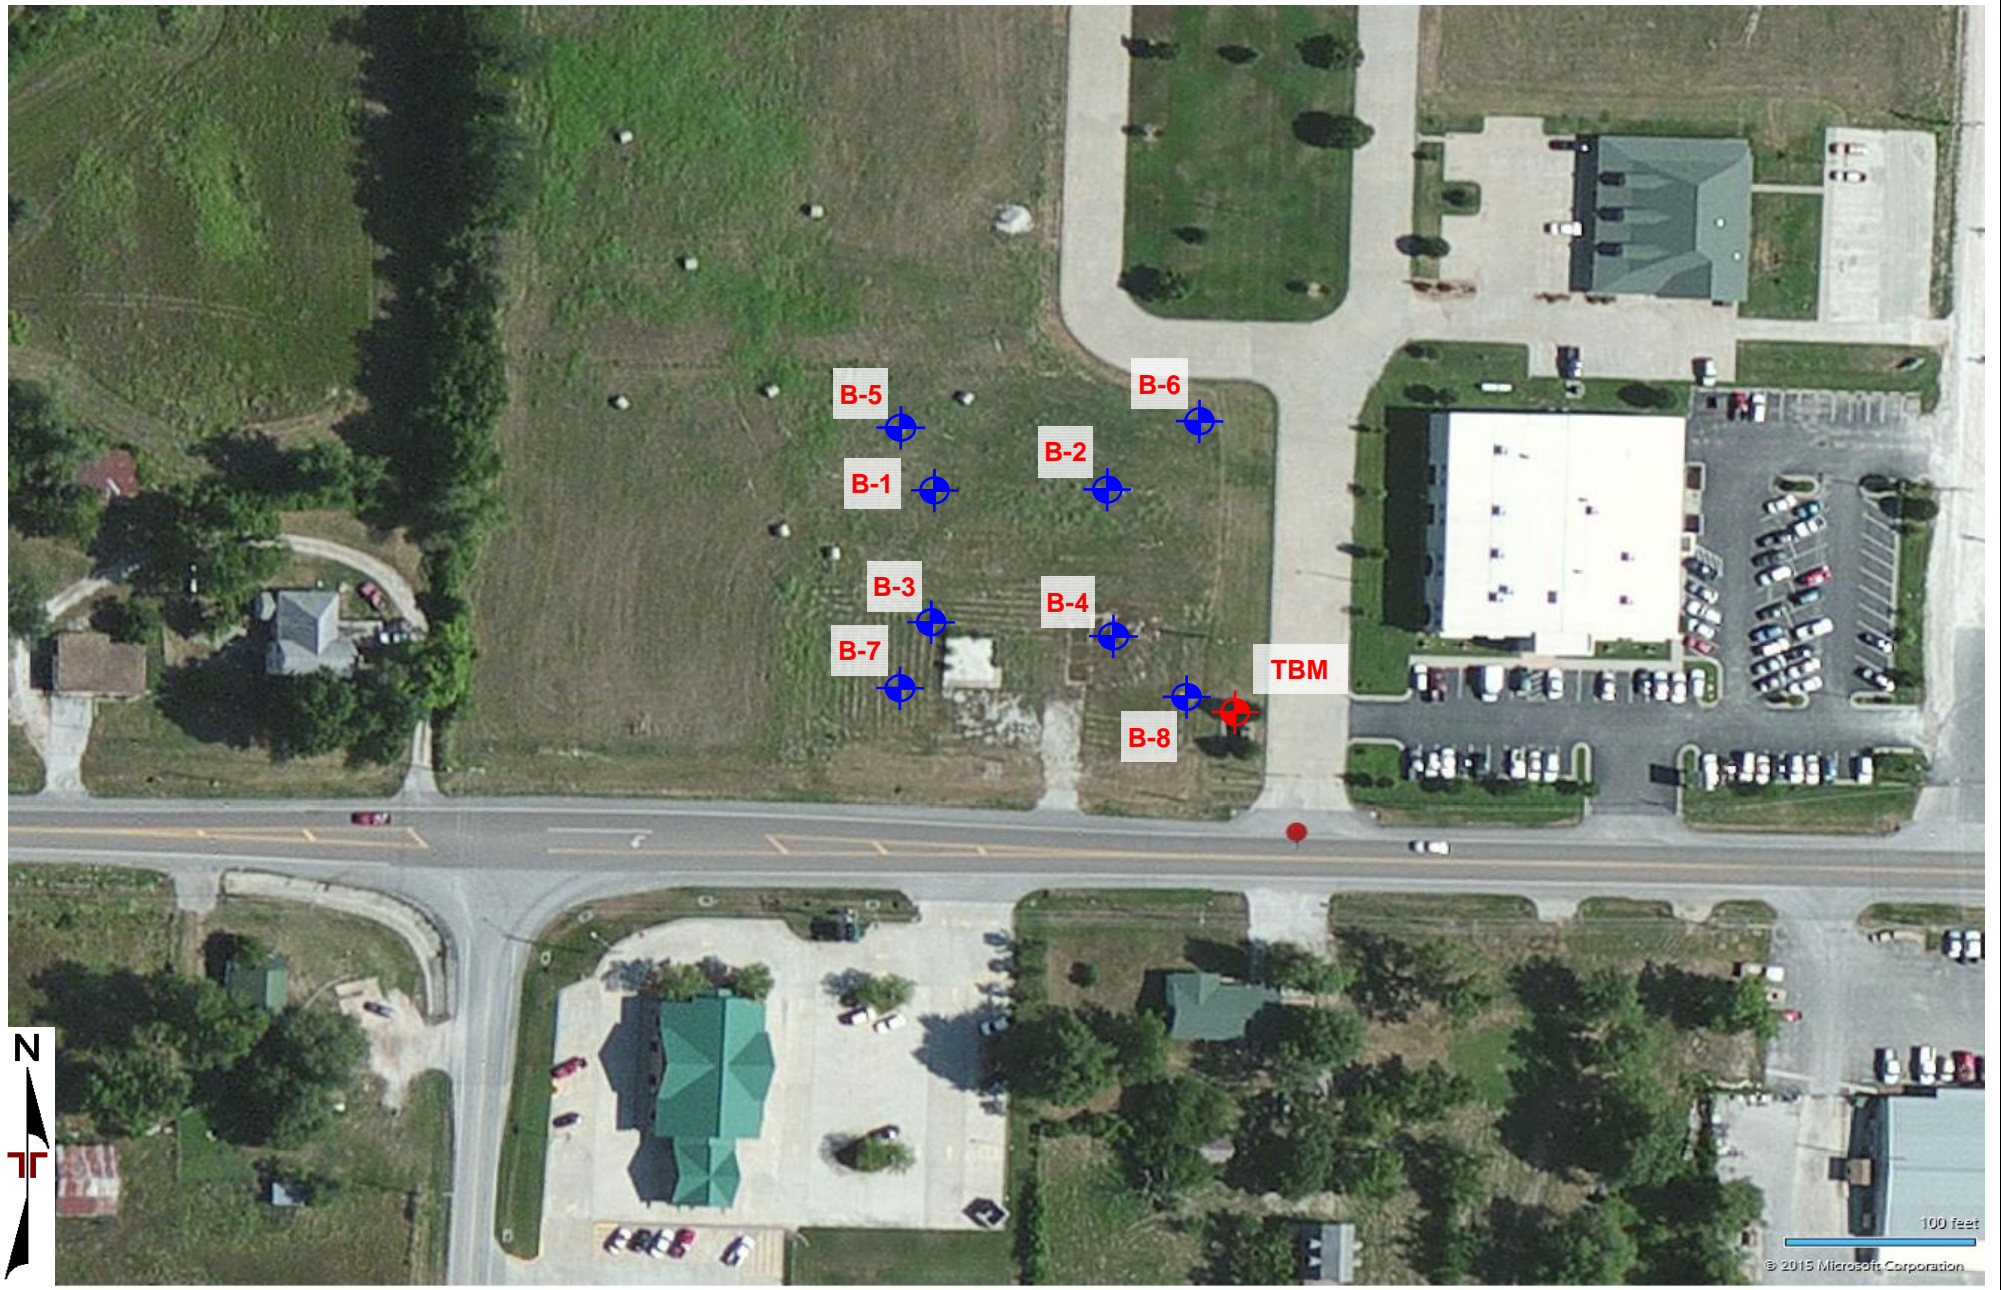
Temporary Benchmark

Terracon Boring
